## **AERIAL ROOF REPORT**

1916 Danniston Crescent, Manchester MA 01944

13 July 2020

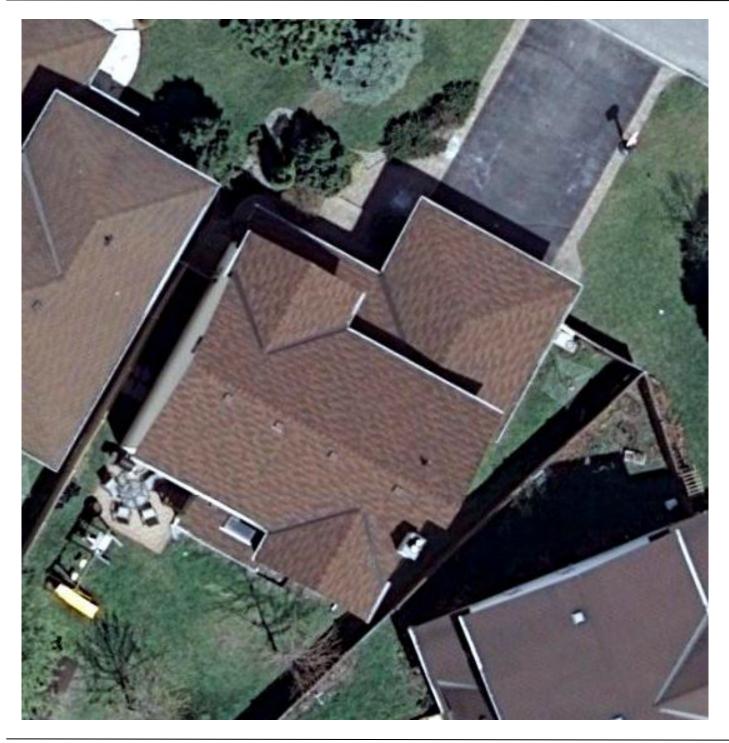
Total Lengths

Total Quantities			
Total Squares	23.84		
-Waste Factor-			
10%	26.22		
15%	27.41		
20%	28.60		
25%	29.80		
Ridge Length	79'		
Eave Length	159'		
Hip Length	37'		
Valley Lengths	70'		
Transition Length	0'		
Rake/ Gable Length	126'		
Step Flashing	22'		
Apron Flashing	45'		
Perimeter (Eave +Gable)	286′

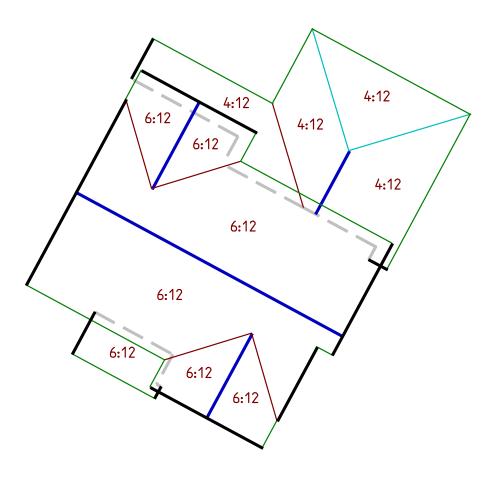
4:12	6:12
Total Squares	7.43	16.40
Ridge Length (ft)	10'	69'
Eave Length (ft)	80'	79'
Hip Length (ft)	37'	0'
Valley Length (ft)	16'	55'
Gable Length (ft)	10'	117'
Step Flashing (ft)	17'	5'
Apron Flashing (ft)	32'	13'
