AERIAL ROOF REPORT

25 March 2020

248 Castlegarth Crescent, Nepean, ON K2J 5N6,

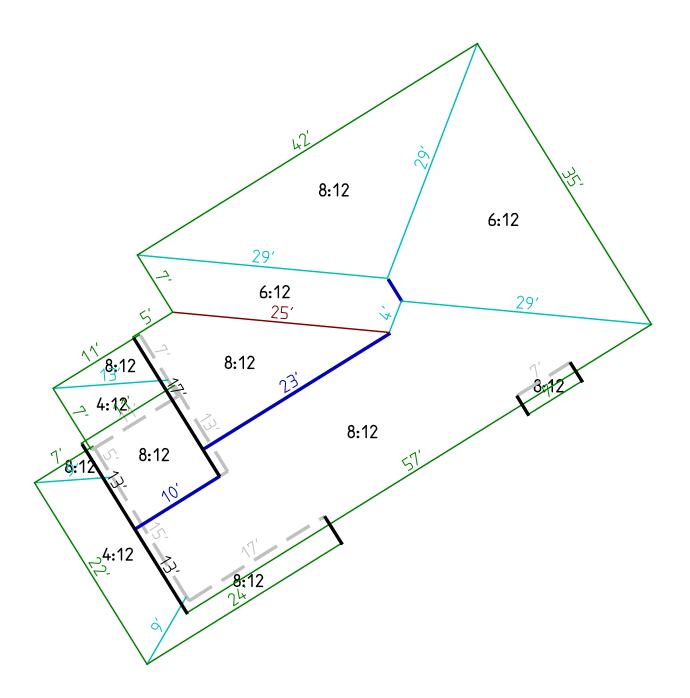
Total Roof Squares = 25.17								
Waste Factor								
10%	15%	20%	25%					
27.68	28.94	30.20	31.46

Ridge Length=36'

Valley Lengths=25'

Hip Length=119'

Eave Length=235'

Rake Length=56'

Perimeter (Eave +Gable)=291'

Transition Length=0'

Step Flashing=37'

Apron Flashing=40'

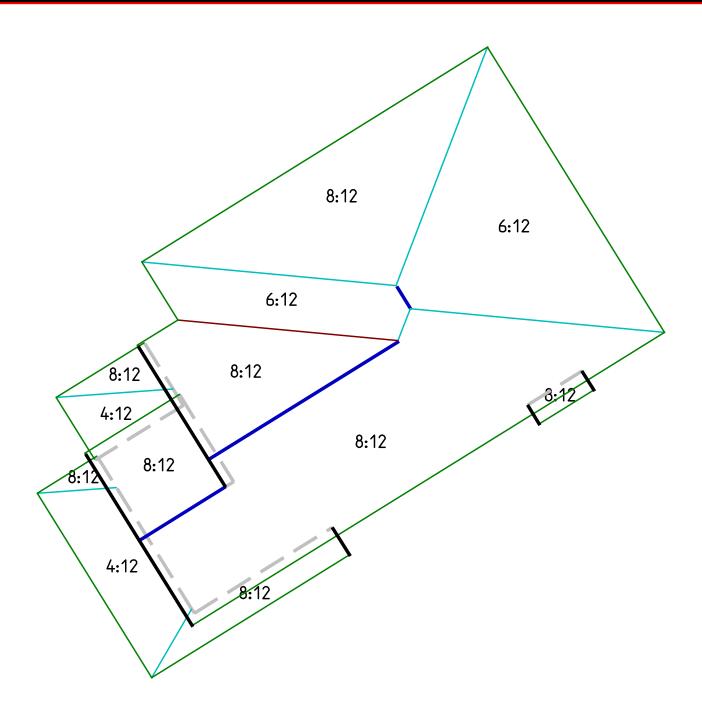
1:12	2:12	3:12	4:12	5:12	6:12	7:12	8:12	12:12
Total Squares				1.95		6.03		17.19	
Ridge Length (ft)				0'		3'		33'	
Eave Length (ft)				30'		42'		164'	
Hip Length (ft)				30'		89'		0'	
Valley Length (ft)				0'		25'		0'	
Gable Length (ft)				0'		0'		56'	
Step Flashing (ft)				11'		0'		26'	
Apron Flashing (ft)				17'		0'		23'
