Customer Information

1 Flatley Ave,

Manchester MA 01944,

MyRoofReport

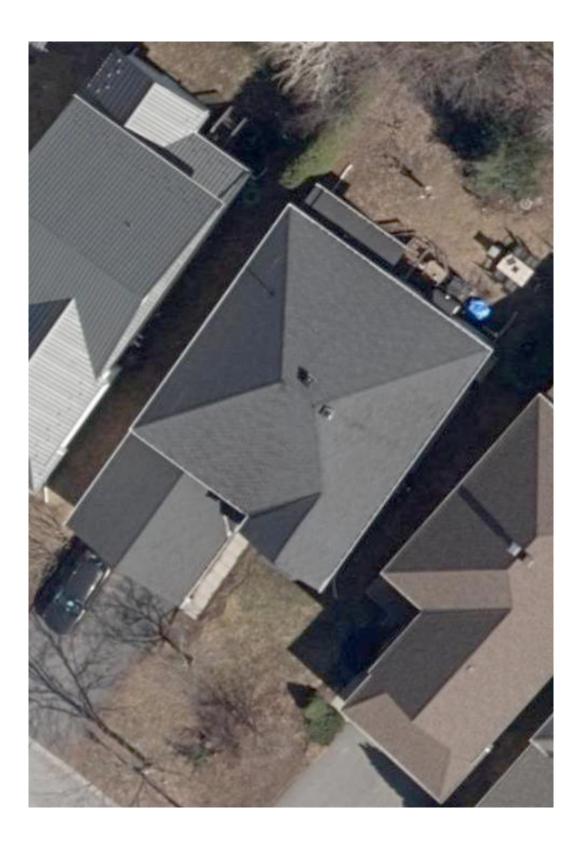
Total Roof S	quares = 27.86		
-Waste Factor-				
10%	15%	20%	25%	
30.65	32.04	33.43	34.82

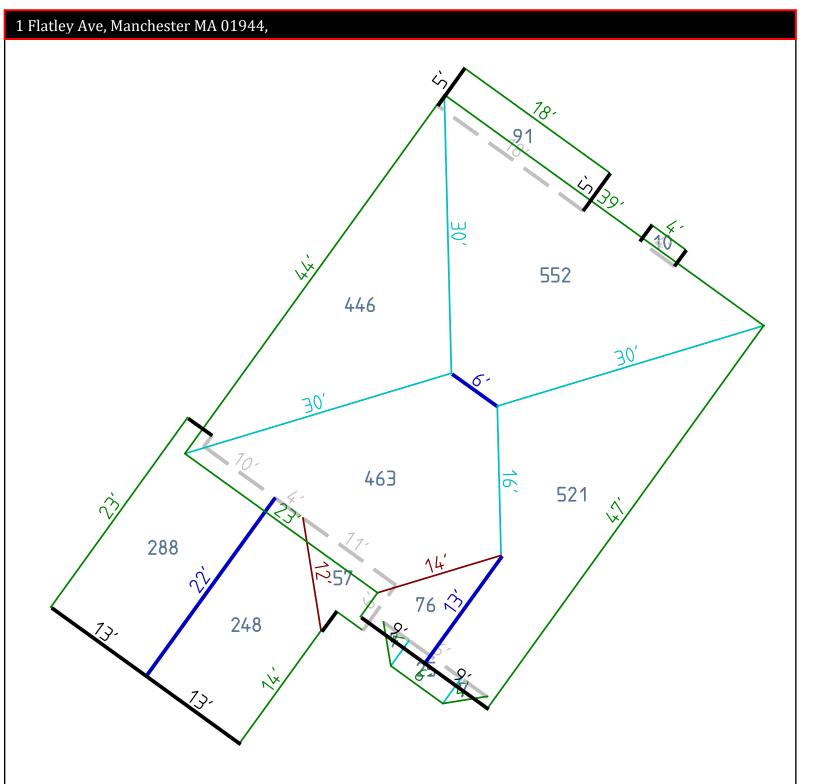
Total Quantities

Ridge Length=40'

Eave Length=233'

Transition Length=0'

Valley Lengths=26'

Rake Length=66'

Step Flashing=28'

Hip Length=113'

Perimeter (Eave +Gable)=298'

Apron Flashing=41'

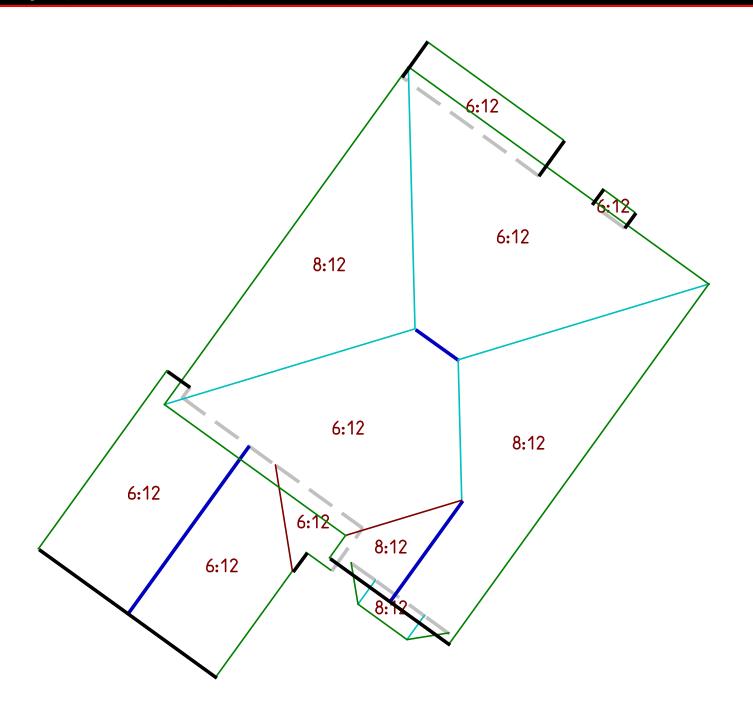
m . 16	6:12	8:12
Total Squares	17.06	10.80
Ridge Length (ft)	27'	13'
Eave Length (ft)	124'	108'
Hip Length (ft)	0'	113'
Valley Length (ft)	12'	14'
Gable Length (ft)	47'	19'
Step Flashing (ft)	20'	8'
Apron Flashing (ft)	34'	6'

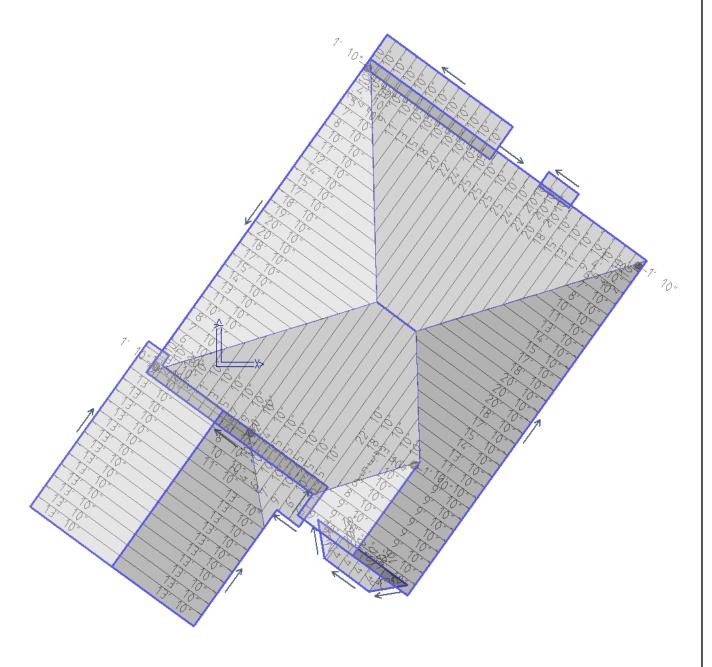
Standing Seam Panel Size	18"
Total Panel Length	2,085'
Sheet Area	31.27 sq
Roof Area	27.86 sq
Panel Area/ Roof Area Estimated Waste	11%
